Carson Reserve *Reservoir* **Skamania County PUD**

**Report of Findings
From the
Diving Operations
Conducted on**

June 22, 2011

Underwater Inspection Of Carson Reserve Reservoir

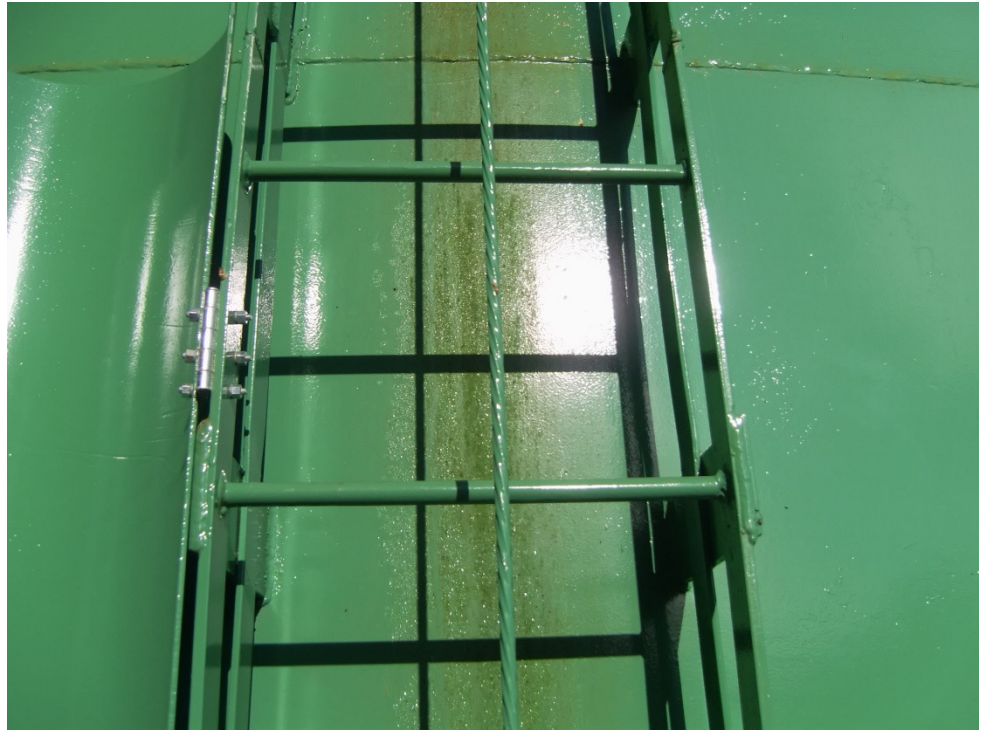
Image #1

Condition:
Rust Grade¹ 8.

Description:
Ladder appears to be in good condition with a minor amount of corrosion.

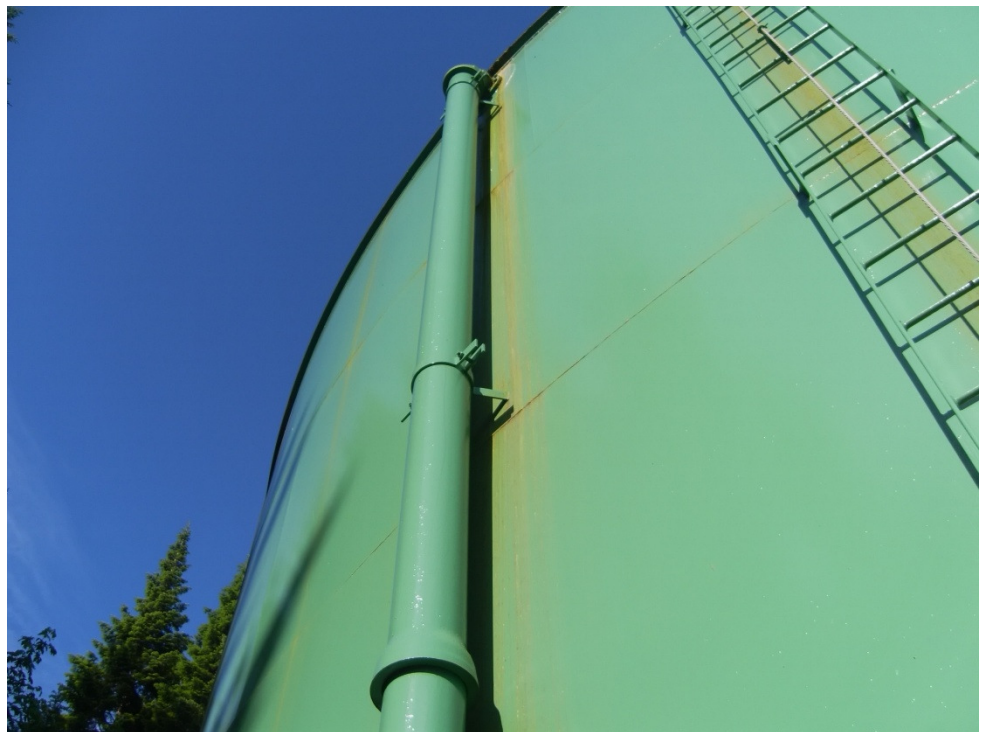
Image #2

Condition:
Rust Grade¹ 8.

Description:
8" Overflow appears to be in good condition with a minor amount of corrosion.

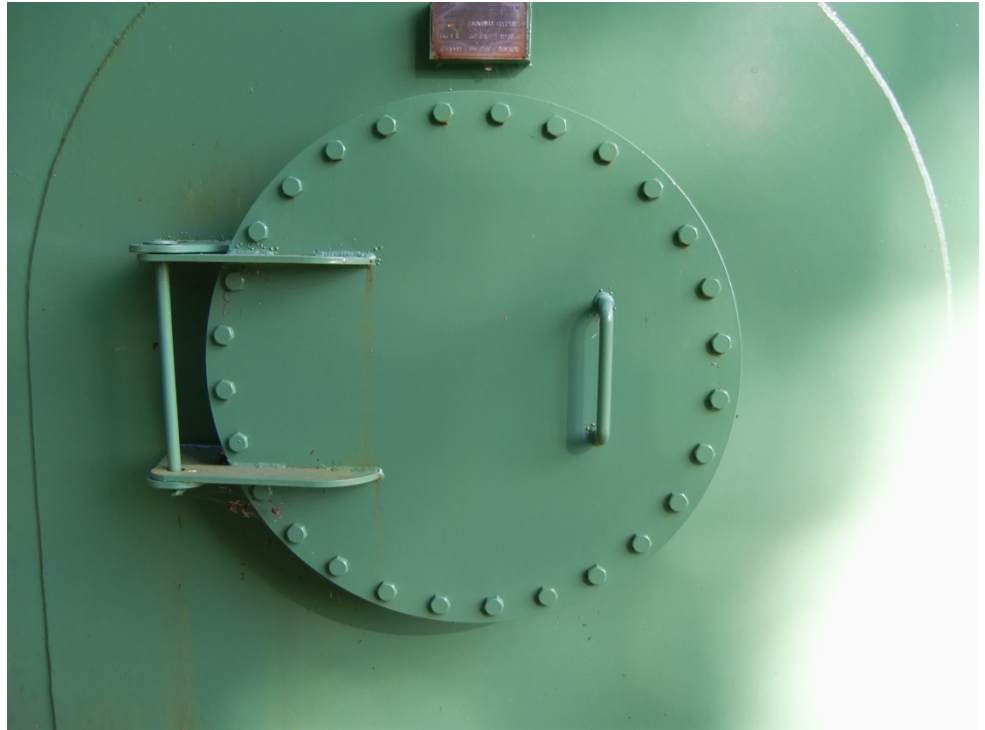
Image #3

Condition:
Rust Grade¹ 9.

Description:
Man Way appears to be in good condition with a minor amount of corrosion.

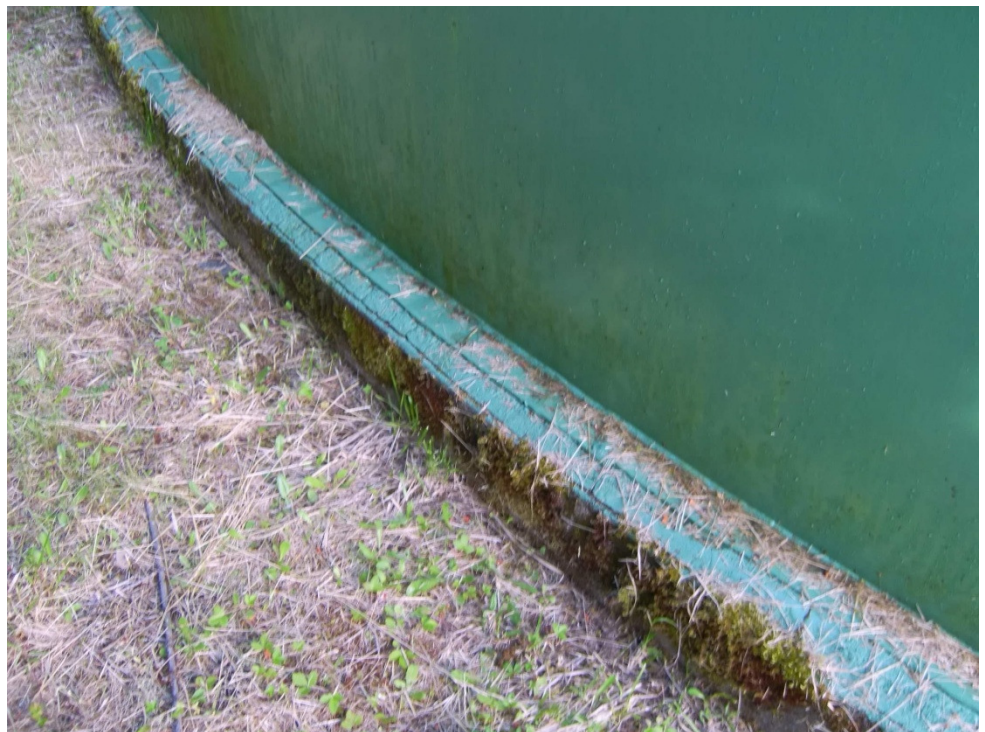
Image #4

Condition:
Rust Grade¹ 8.
Concrete Deform⁵ GC.

Exterior Base appears to be in good condition with a minor amount of corrosion and no signs of concrete problems.

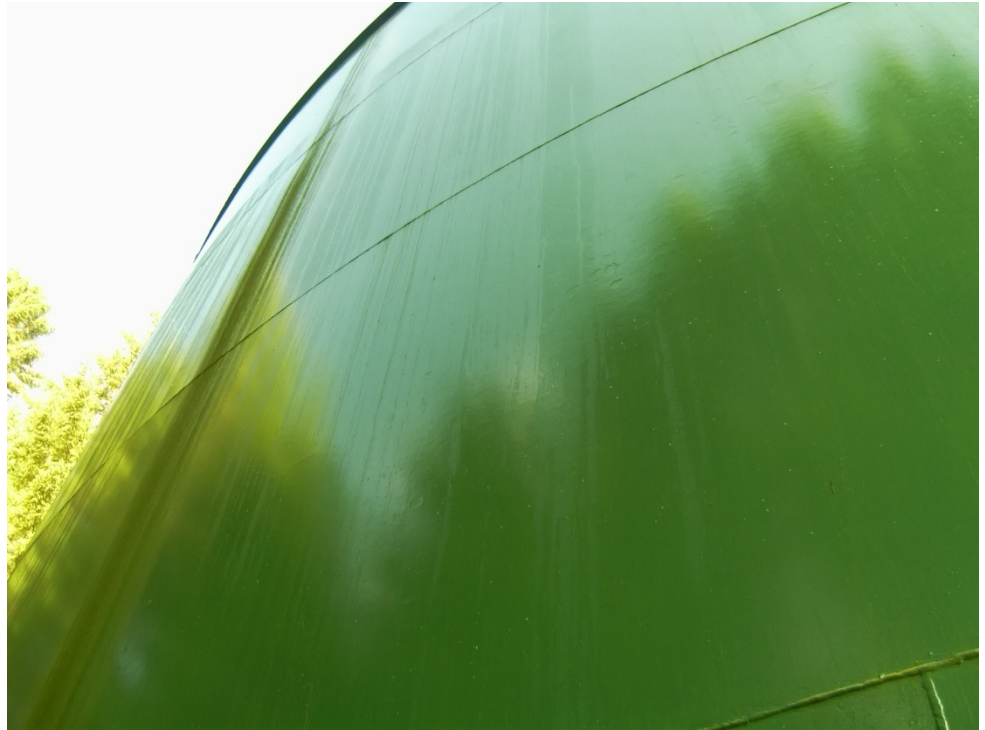
Image #5

Condition:
Rust Grade¹ 9.

Description:
Exterior Wall appears to be in good condition with a minor amount of corrosion.

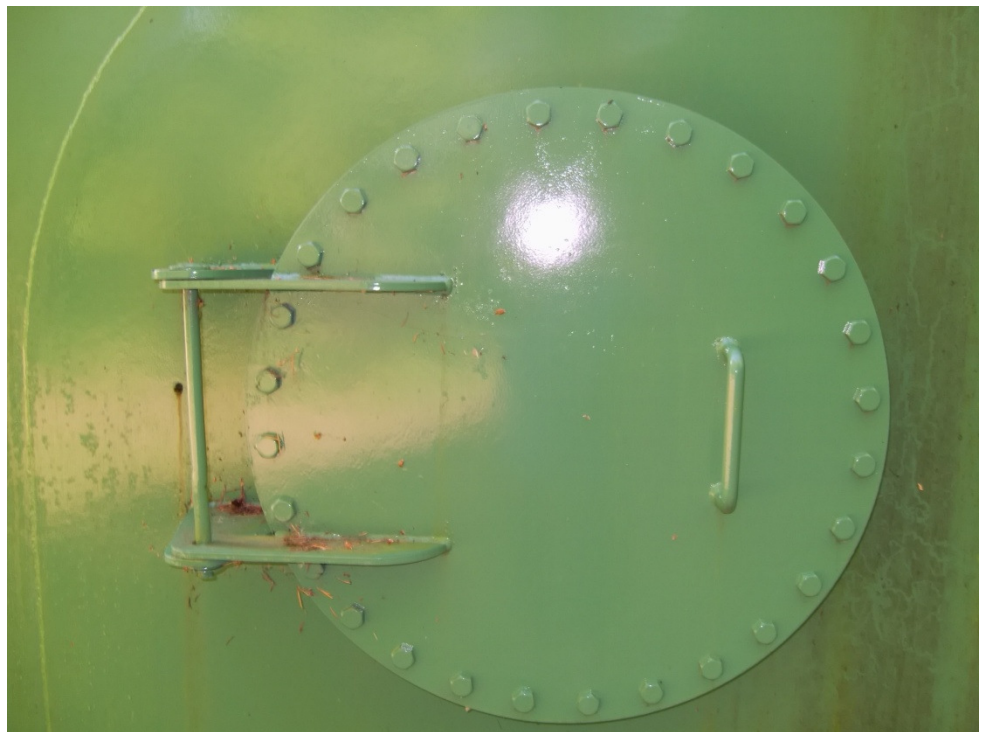
Image #6

Condition:
Rust Grade¹ 8.

Description:
Man Way appears to be in good condition with a minor amount of corrosion.

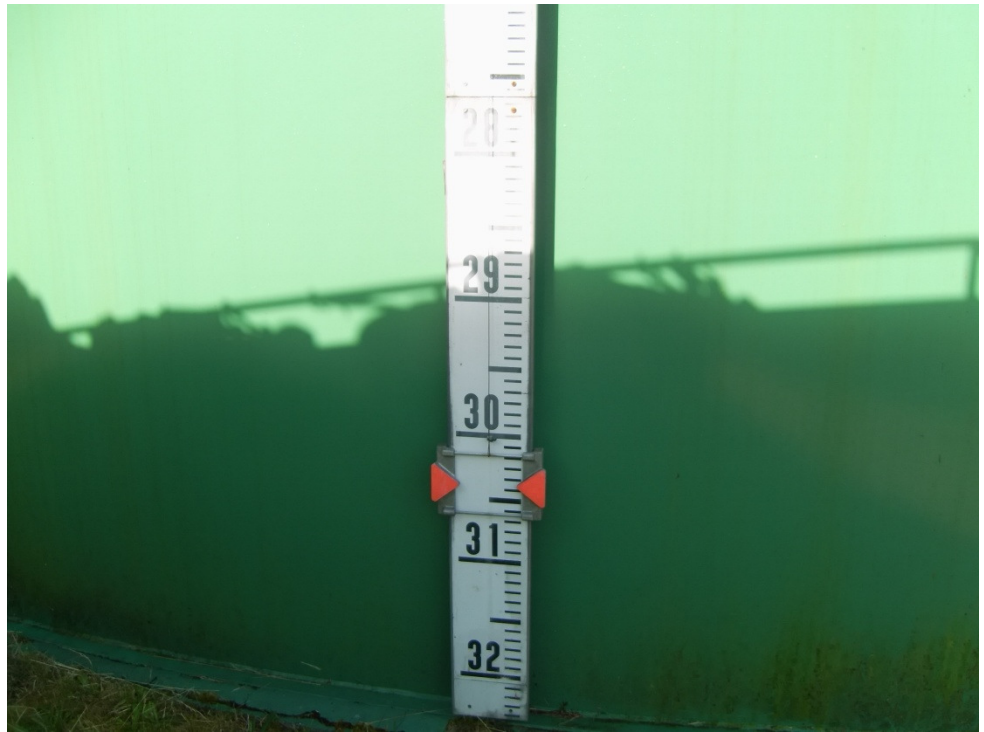
Image #7

Condition:
Rust Grade¹ 8.

Description:
Liquid Level Indicator
Reader board appears
to be in good condition
with a minor amount of
corrosion.

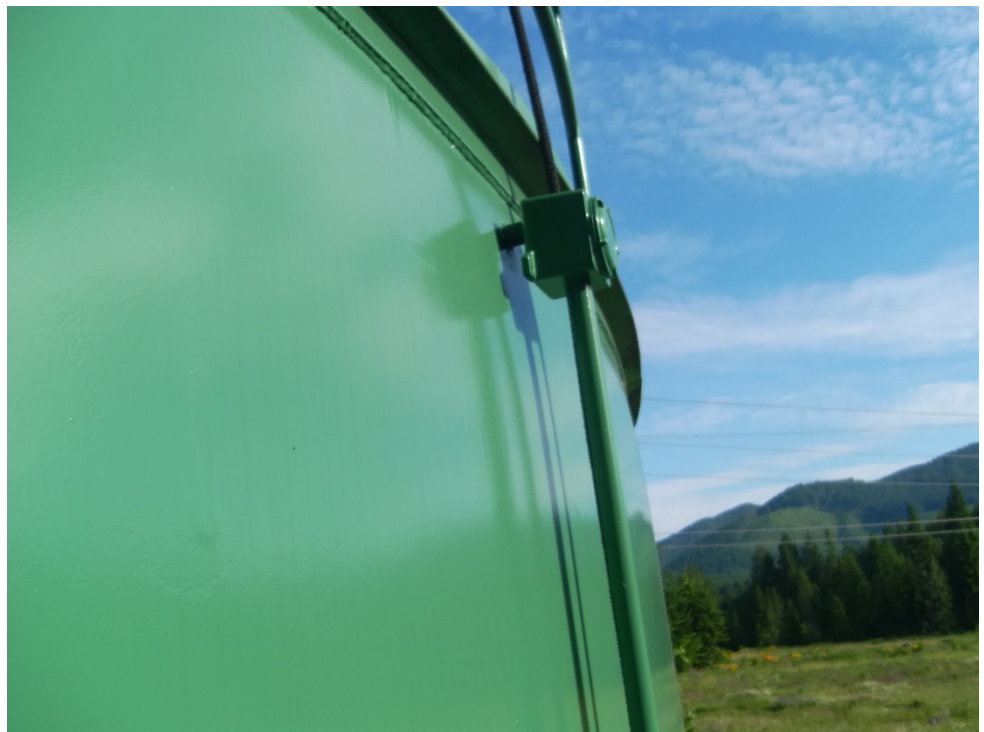
Image #8

Condition:
Rust Grade¹ 9.

Description:
1" Telemetry
Penetration appears to
be in good condition
with a minor amount of
corrosion.

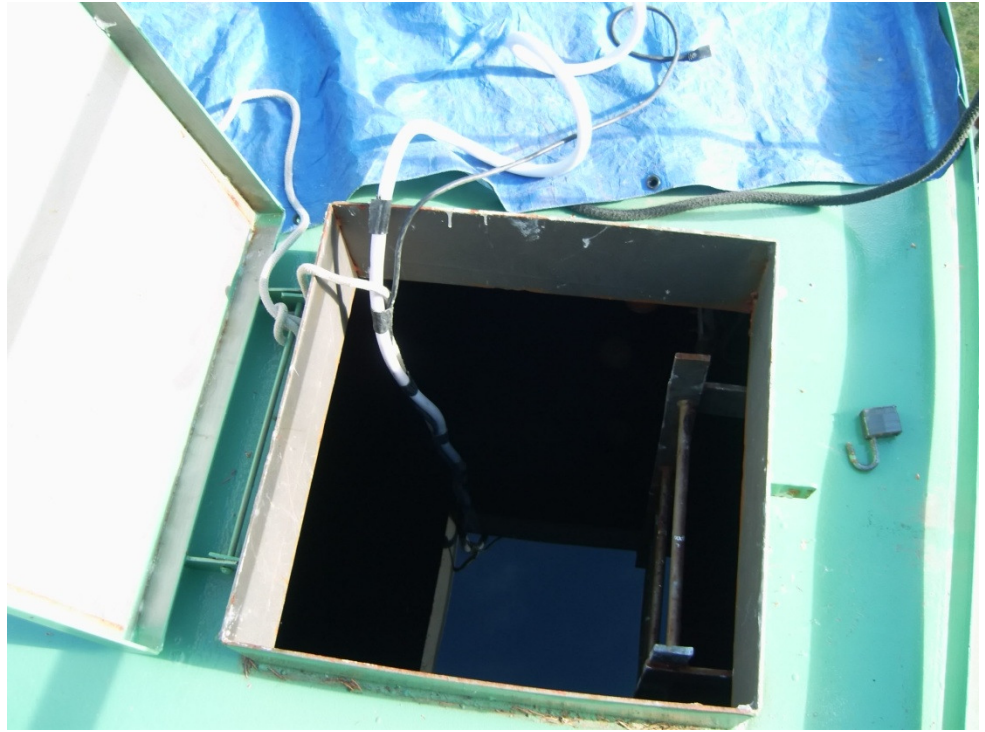
Image #9

Condition:
Rust Grade¹ 8.

Description:
24" x 24" Hatch appears to be in good condition with a minor amount of corrosion.

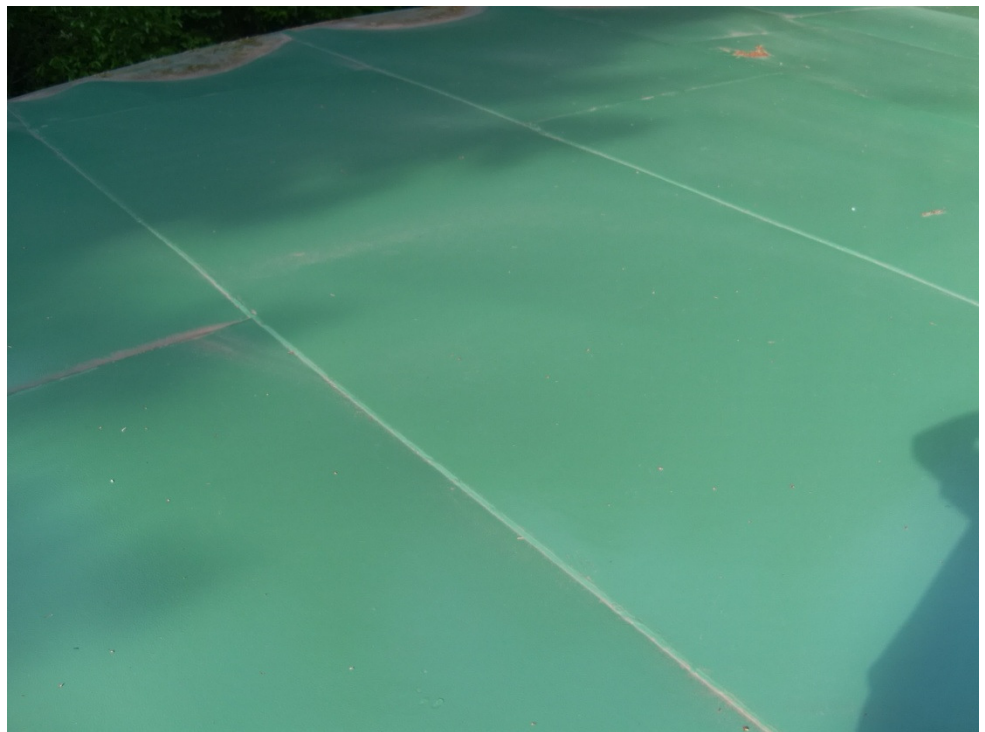
Image #10

Condition:
Rust Grade¹ 9.

Description:
Roof appears to be in good condition with a minor amount of corrosion.

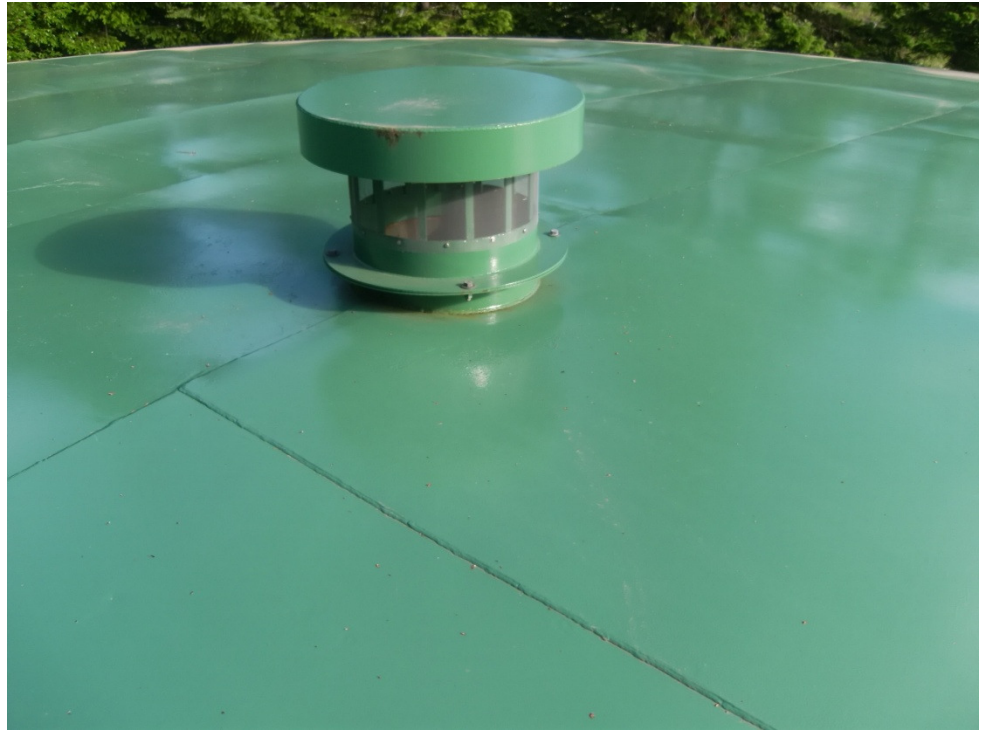
Image #11

Condition:
Rust Grade¹ 9.

Description:
24" Vent appears to be in good condition with a minor amount of corrosion. A fine mesh screen was observed to be in place and in tack.

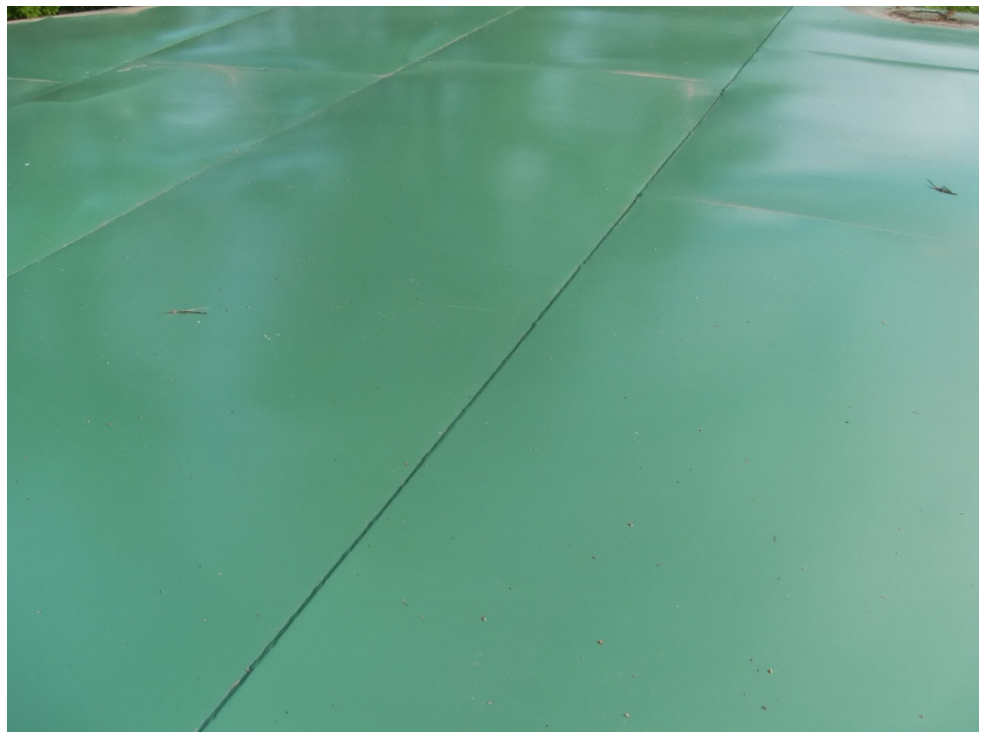
Image #12

Condition:
Rust Grade¹ 9.

Description:
Roof appears to be in good condition with a minor amount of corrosion.

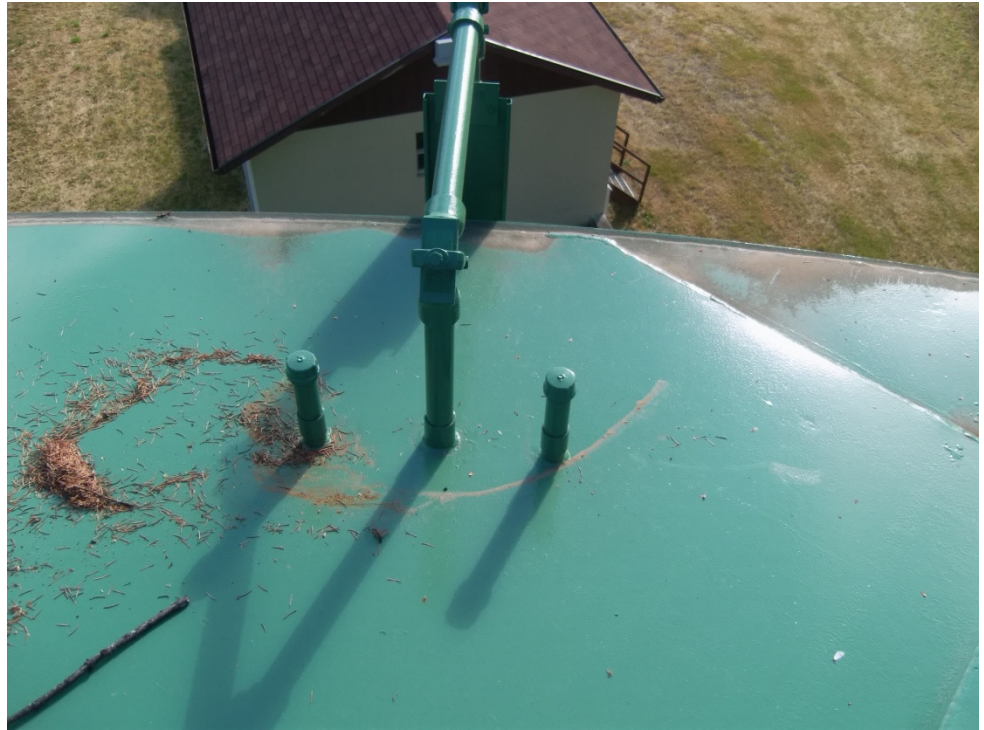
Image #13

Condition:
Rust Grade¹ 9.

Description:
1" Liquid Level
Indicator penetration
appears to be in good
condition with a minor
amount of corrosion.

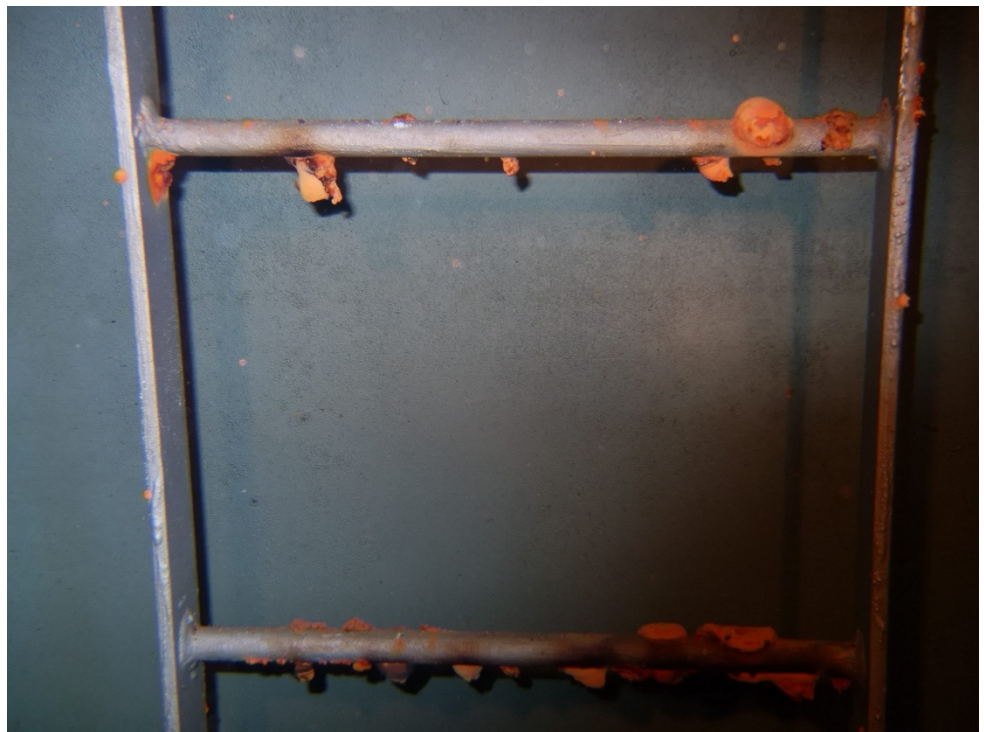
Image #14

Condition:
Rust Grade¹ 5.

Description:
Ladder appears to be
in fair condition with a
moderate amount of
corrosion. Rust
nodules were observed.

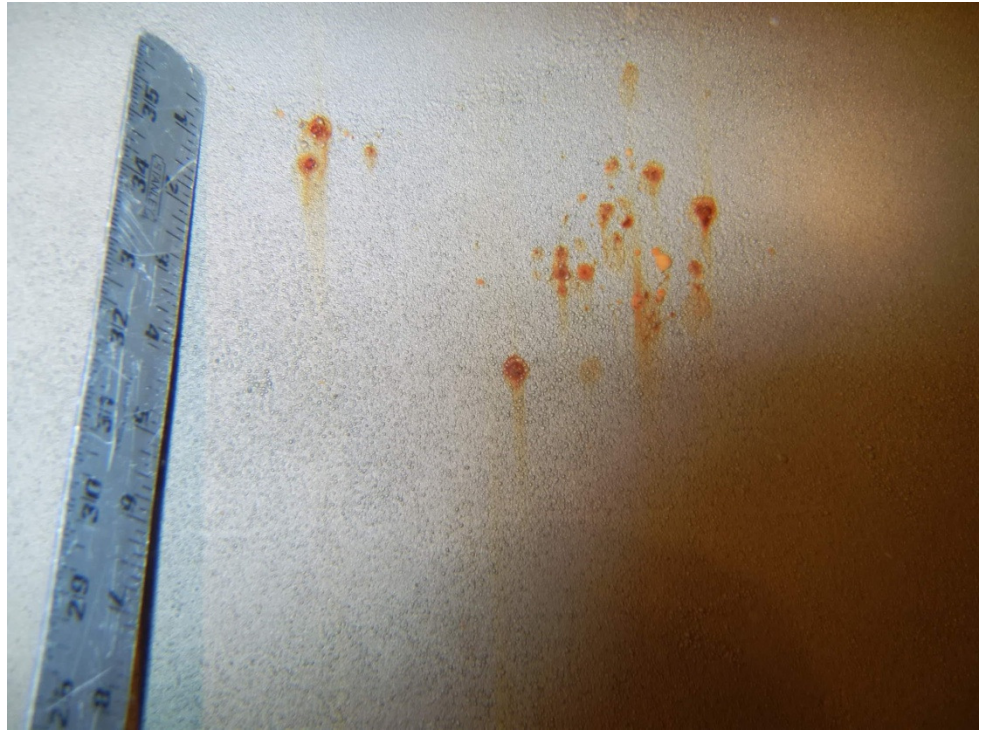
Image #15

Condition:
Rust Grade¹ 2.

Description:
Wall appears to be in fair condition with a minor amount of corrosion. Minor blistering was observed.

Recommendation	Estimated Time - Hrs.
Remove the existing interior coating and apply a new NSF approved epoxy type coating. The existing interior coating was in such disrepair that it would not be cost effective to attempt to patch all of the problem areas.	Please contact our sales office for an estimate.
Perform a regular cleaning, inspection and repair cycle every 2-3 years in order to ensure superior water quality and proper maintenance of coating condition and appurtenances is performed.	Please contact our sales office for an estimate.
Total Estimated Hours

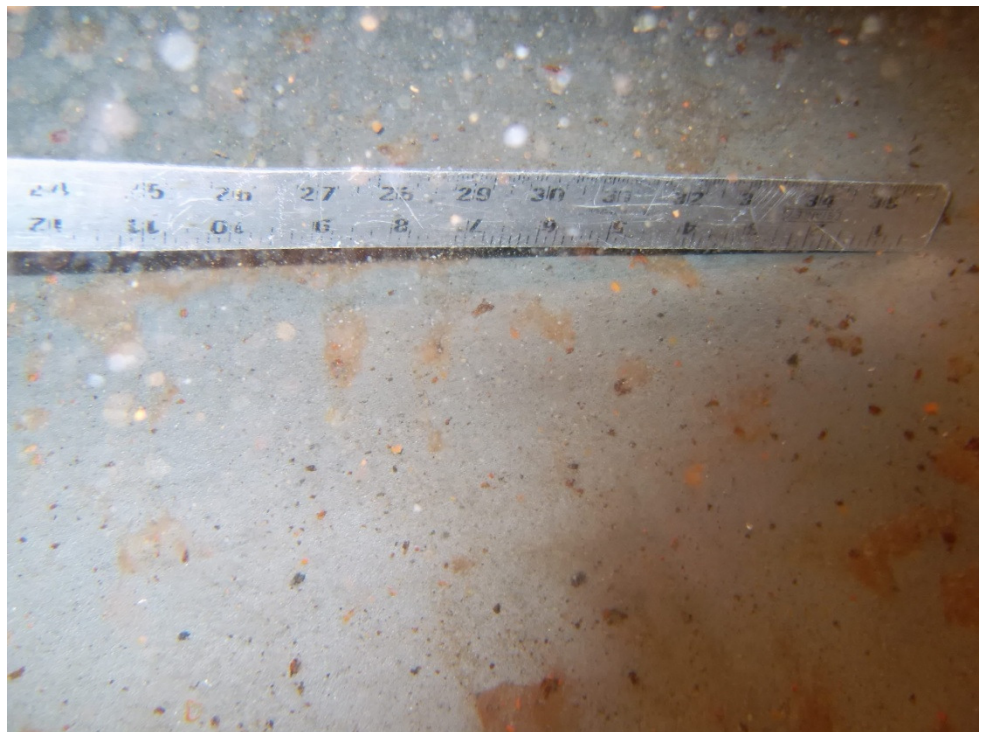
Image #16

Condition:
Rust Grade¹ 2.

Description:
Floor appears to be in poor condition with a heavy amount of corrosion. Heavy blistering was observed.

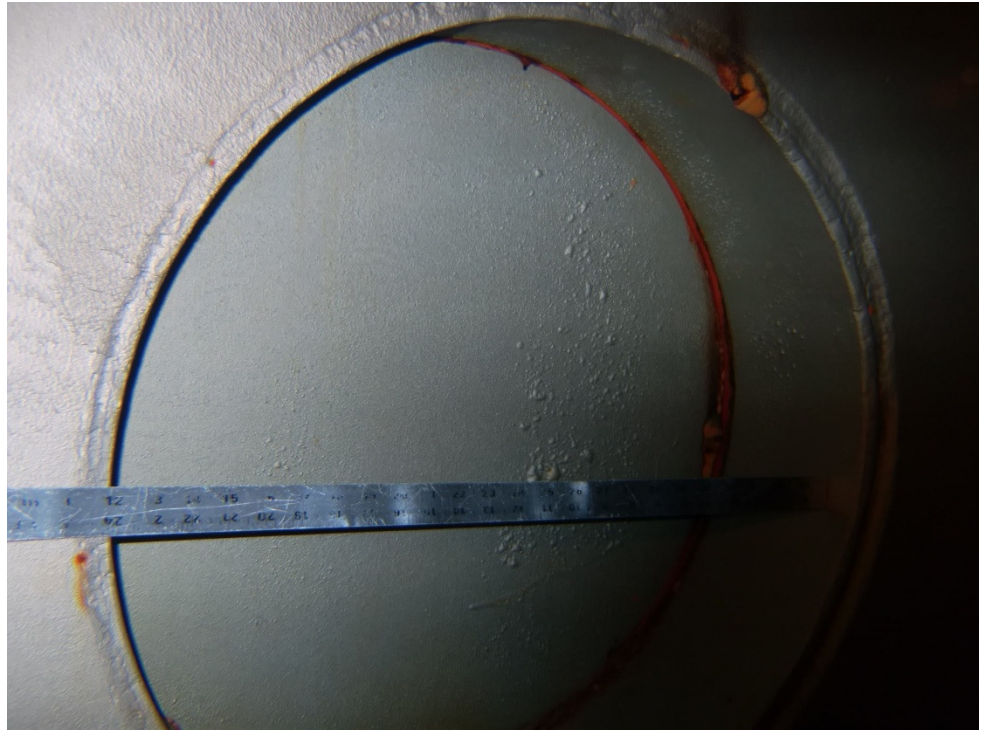
Image #17

Condition:
Rust Grade¹ 6.

Description:
Man Way appears to be in fair condition with a minor amount of corrosion. Moderate blistering was observed.

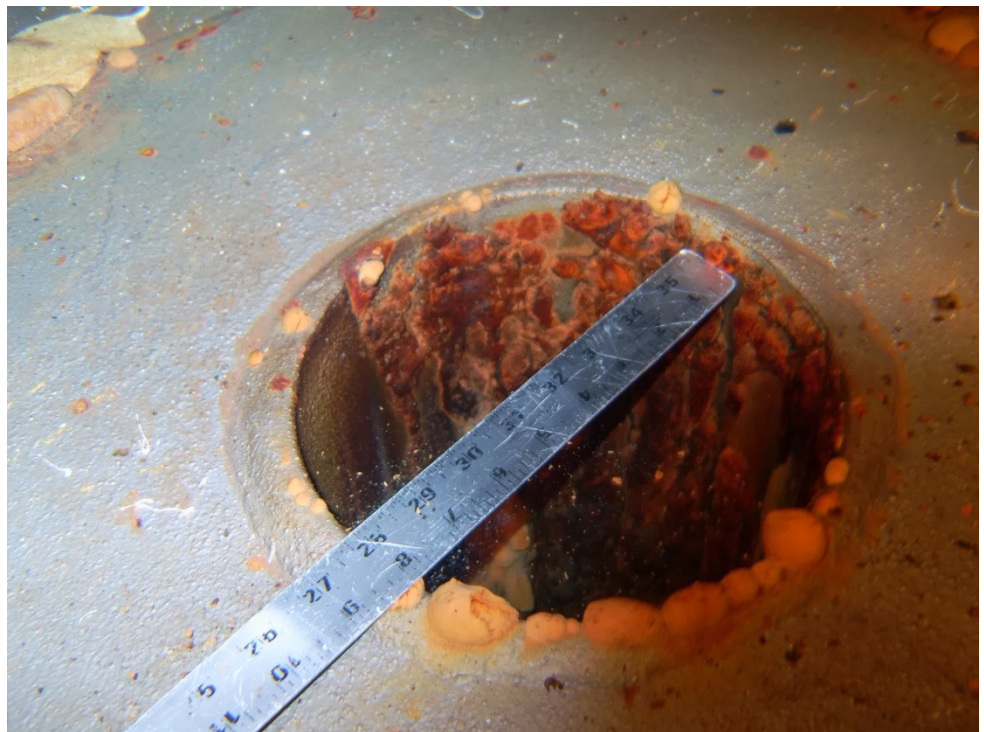
Image #18

Condition:
Rust Grade¹ 0.

Description:
8" Drain appears to be in poor condition with a heavy amount of corrosion.

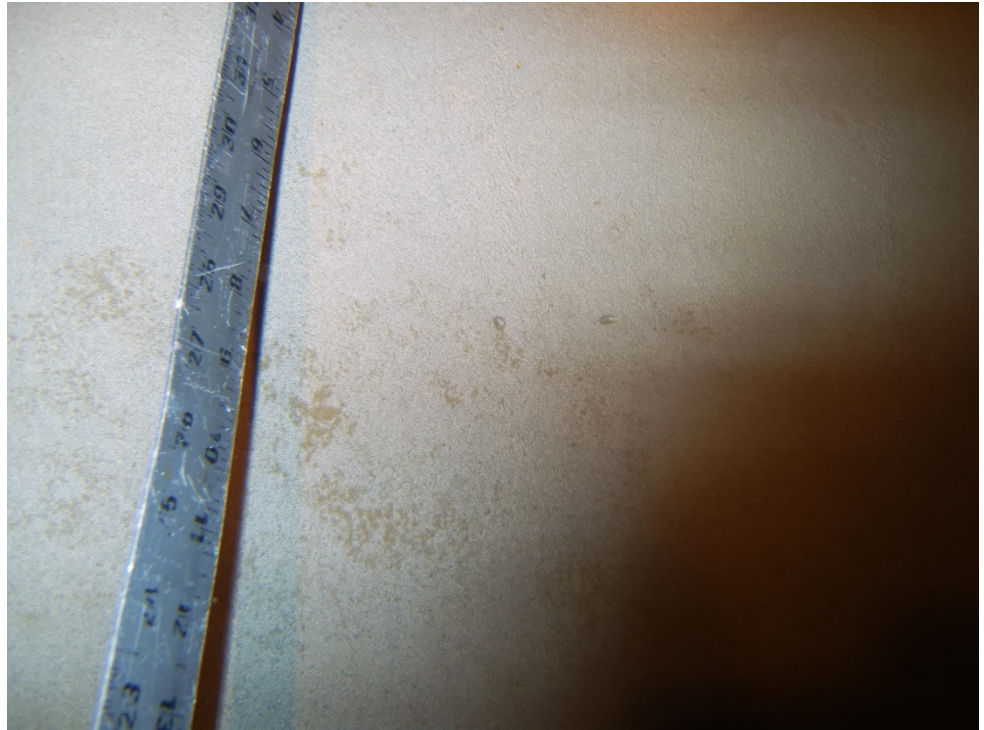
Image #19

Condition:
Rust Grade¹ 7.

Description:
Wall appears to be in fair condition with a minor amount of corrosion. Moderate blistering was observed.

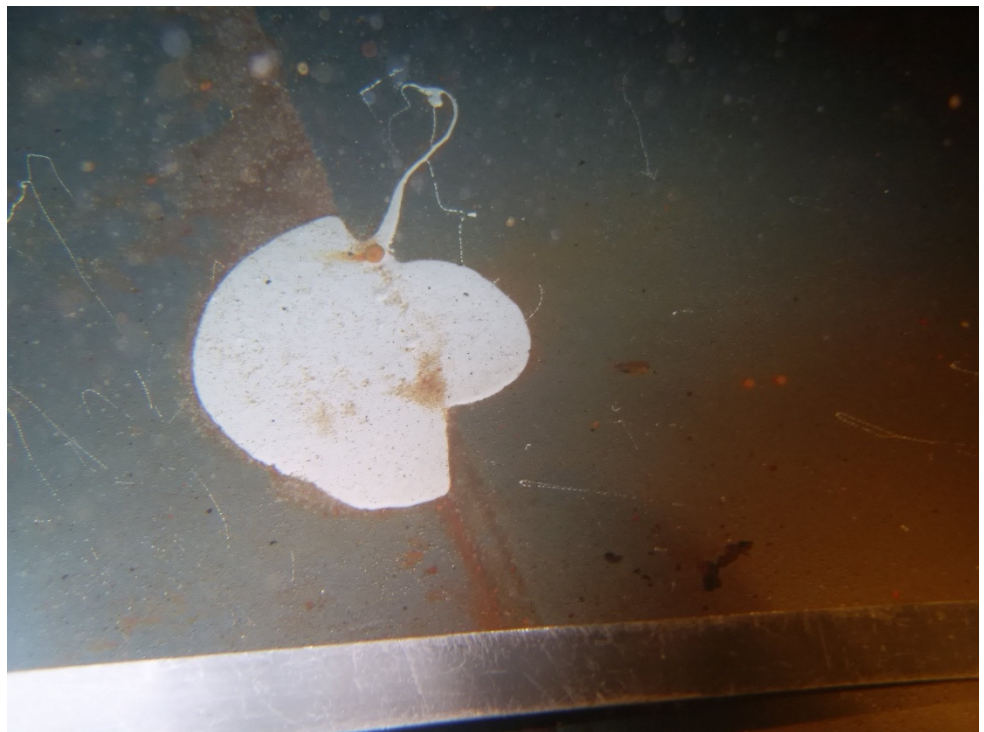
Image #20

Condition:
Rust Grade¹ 2.

Description:
Floor appears to be in poor condition with a heavy amount of corrosion. Heavy blistering was observed.

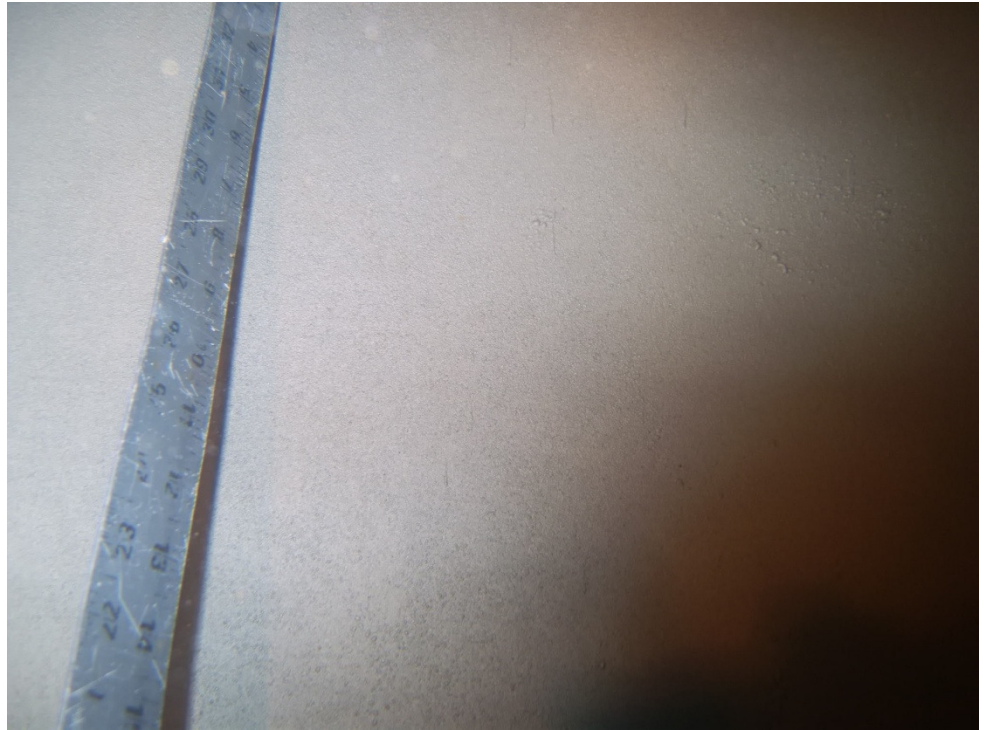
Image #21

Condition:
Rust Grade¹ 7.

Description:
Wall appears to be in fair condition with a minor amount of corrosion. Moderate blistering was observed.

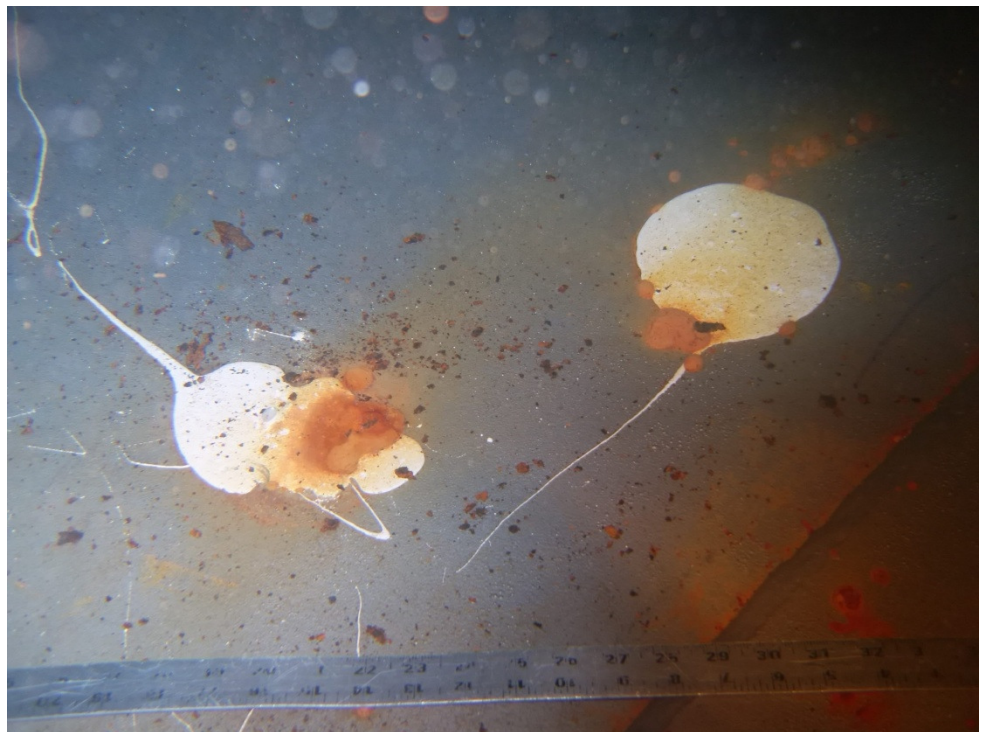
Image #22

Condition:
Rust Grade¹ 2.

Description:
Floor appears to be in poor condition with a heavy amount of corrosion. Heavy blistering was observed.

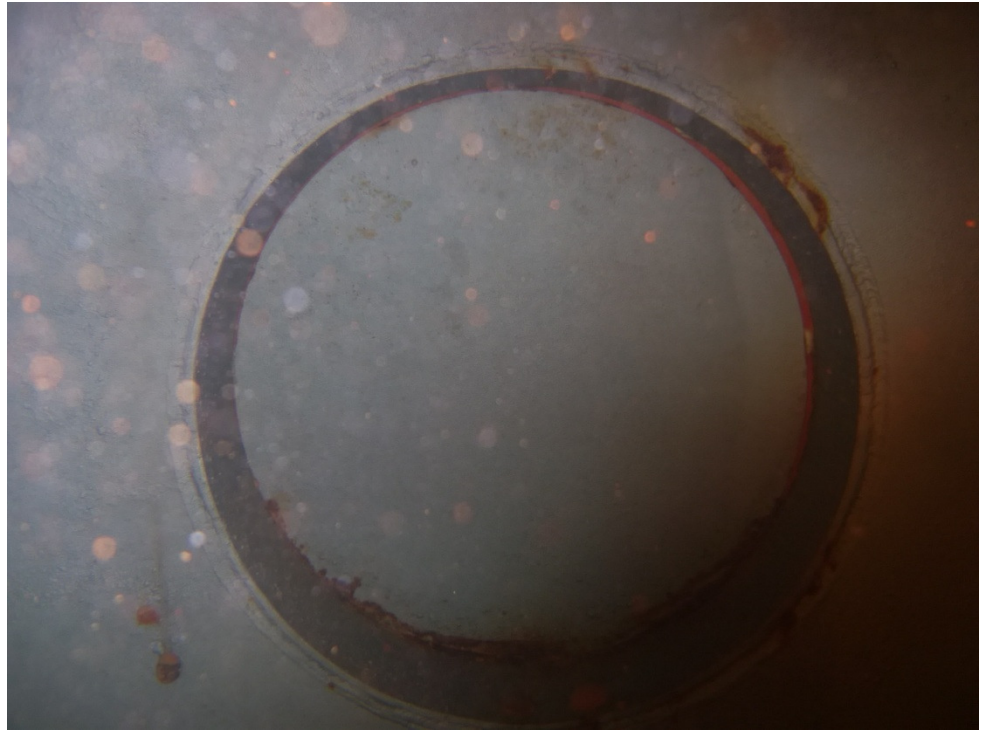
Image #23

Condition:
Rust Grade¹ 5.

Description:
Man Way appears to be in fair condition with a moderate amount of corrosion. Moderate blistering was observed.

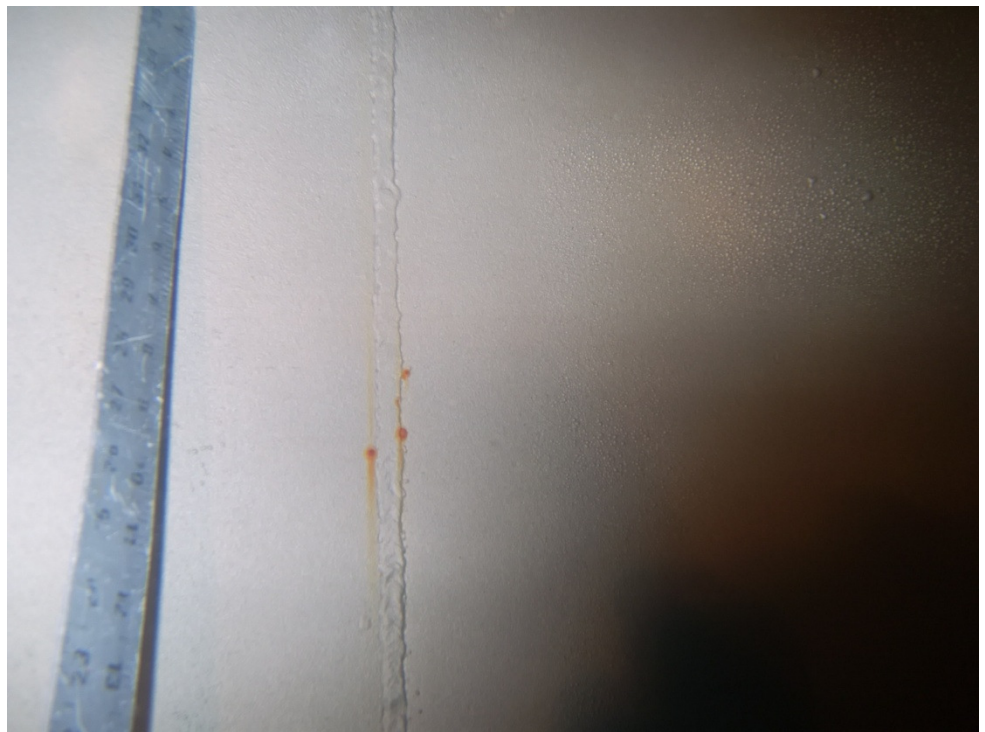
Image #24

Condition:
Rust Grade¹ 7.

Description:
Wall appears to be in fair condition with a minor amount of corrosion. Moderate blistering was observed.

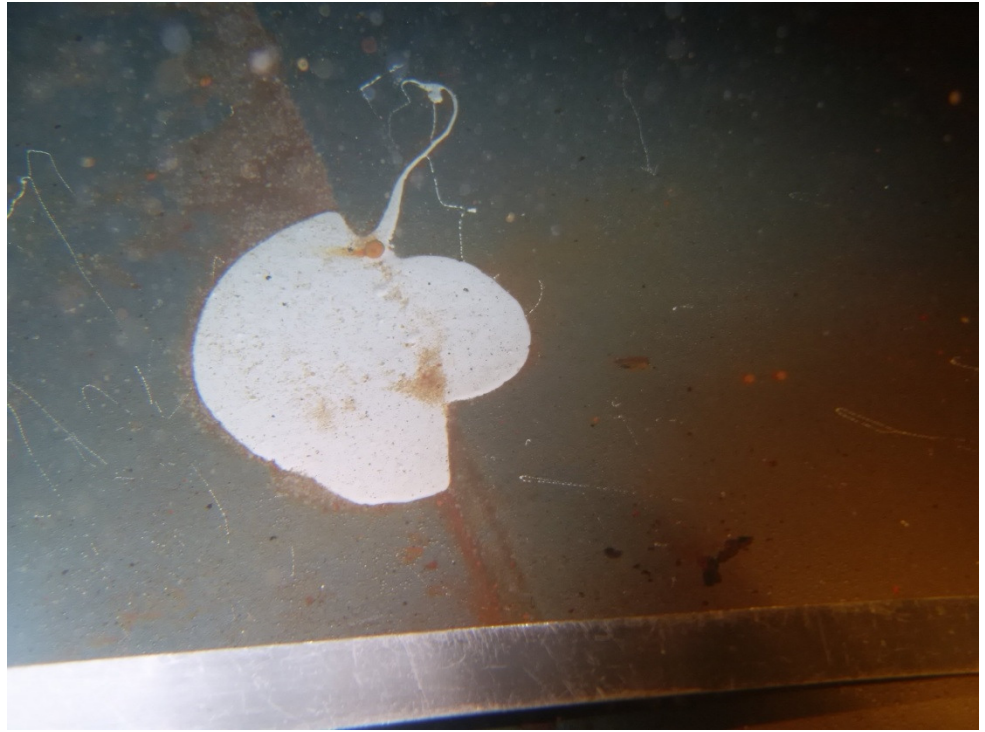
Image #25

Condition:
Rust Grade¹ 2.

Description:
Floor appears to be in poor condition with a heavy amount of corrosion. Heavy blistering was observed.

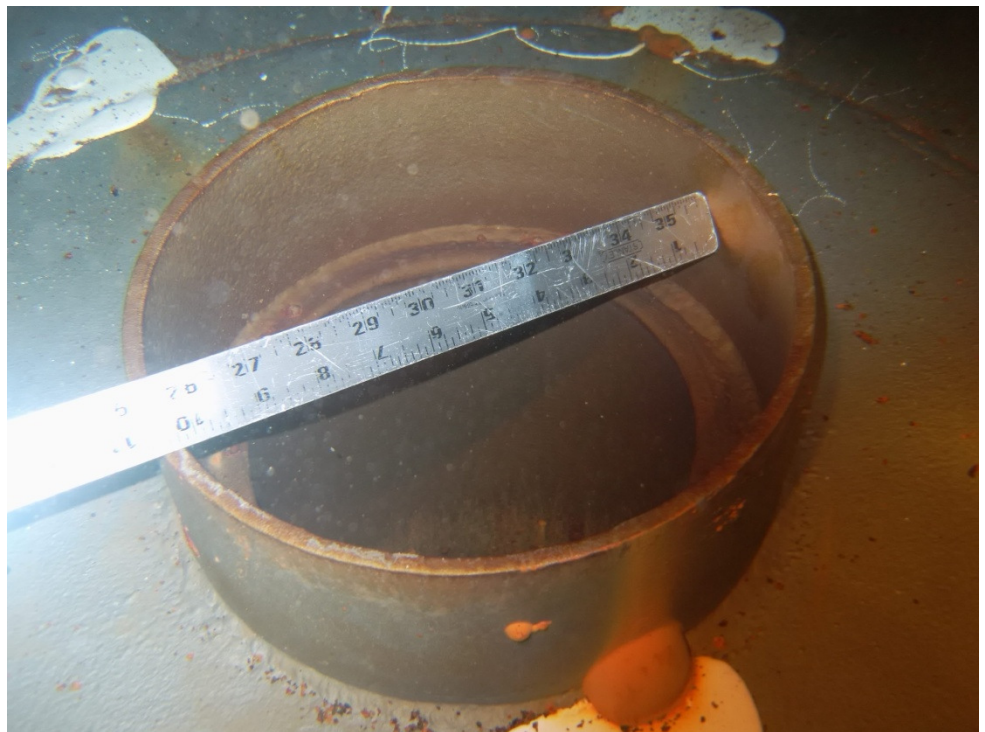
Image #26

Condition:
Rust Grade¹ 5.

Description:
10" Outlet with a 4" sediment ring appears to be in fair condition with a moderate amount of corrosion.

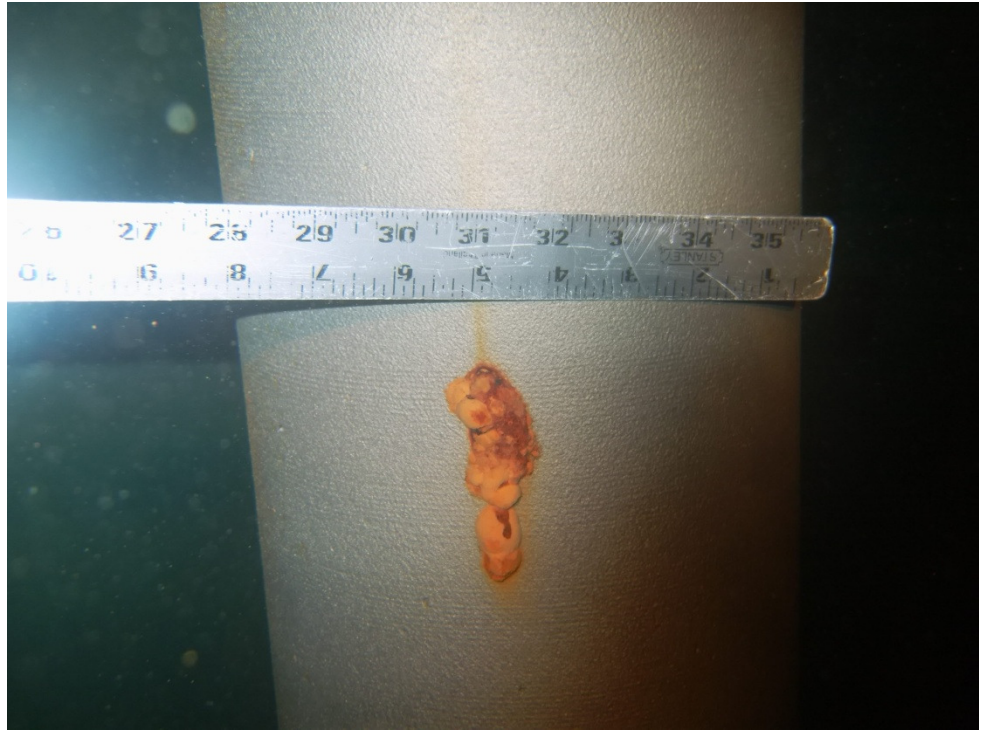
Image #27

Condition:
Rust Grade¹ 7.

Description:
8" High Fill appears to be in good condition with a minor amount of corrosion.

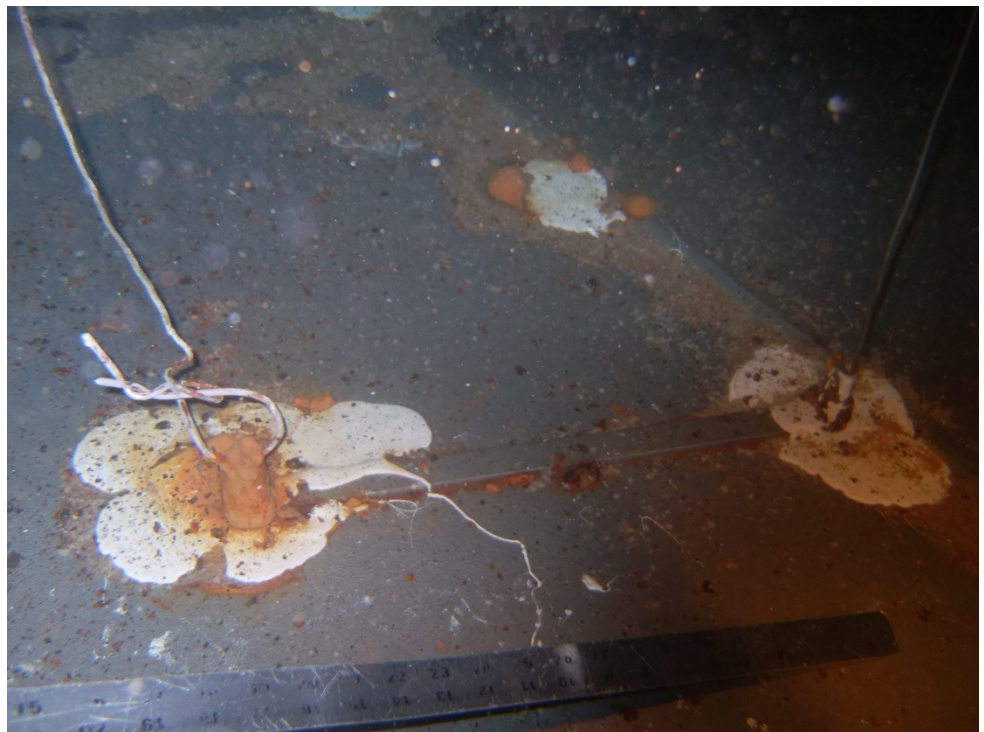
Image #28

Condition:
Rust Grade¹ 9.

Description:
Liquid Level Indicator Guide Wires appears to be in fair condition with a minor amount of corrosion.

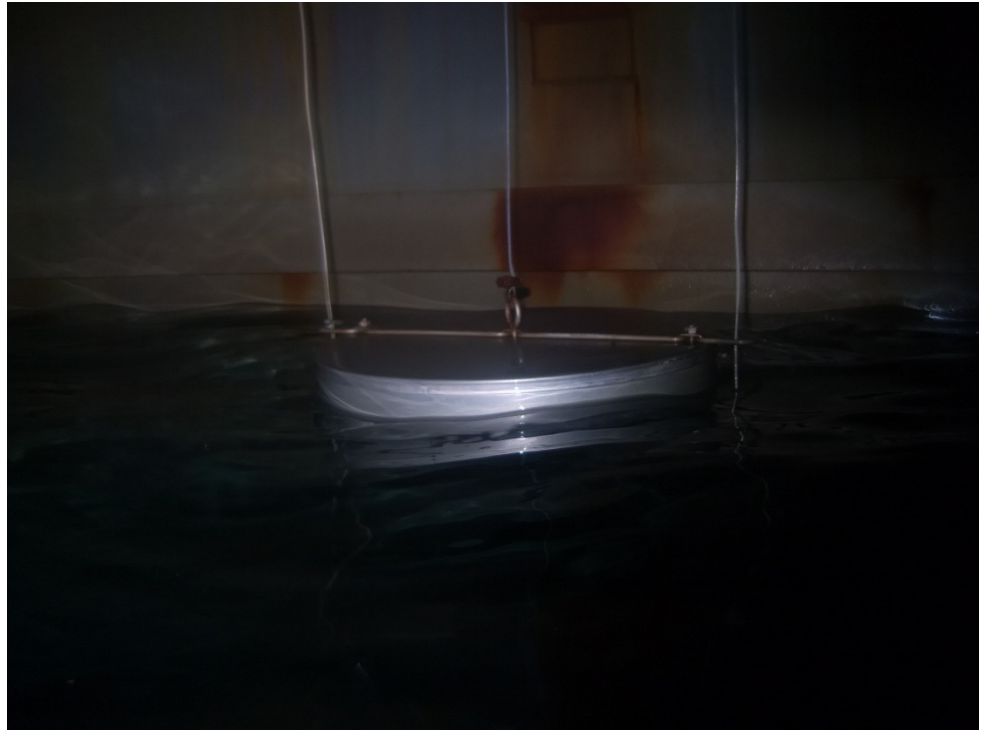
Image #29

Condition:
Rust Grade¹ 9.

Description:
24" Liquid Level Indicator Float appears to be in good condition with a minor amount of corrosion.

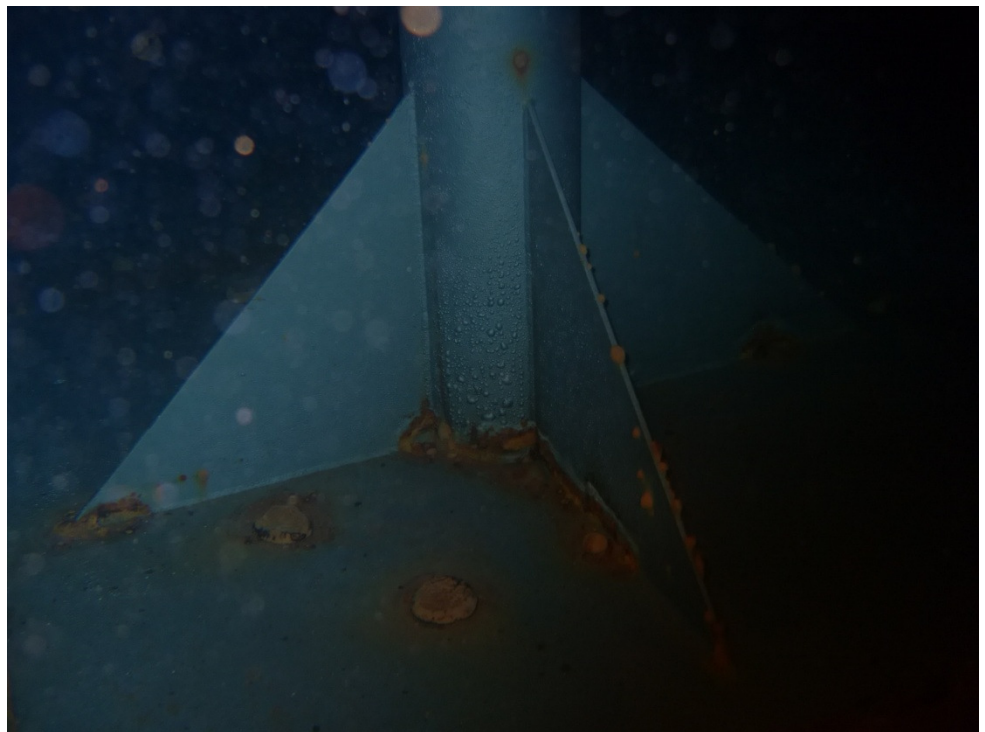
Image #30

Condition:
Rust Grade¹ 5.

Description:
8" Column appears to be in fair condition with a moderate amount of corrosion.
