Carson Reserve *Reservoir* **Skamania County PUD**

**Report of Findings
From the
Diving Operations
Conducted on**

June 22, 2011

Underwater Inspection Of Carson Reserve Reservoir

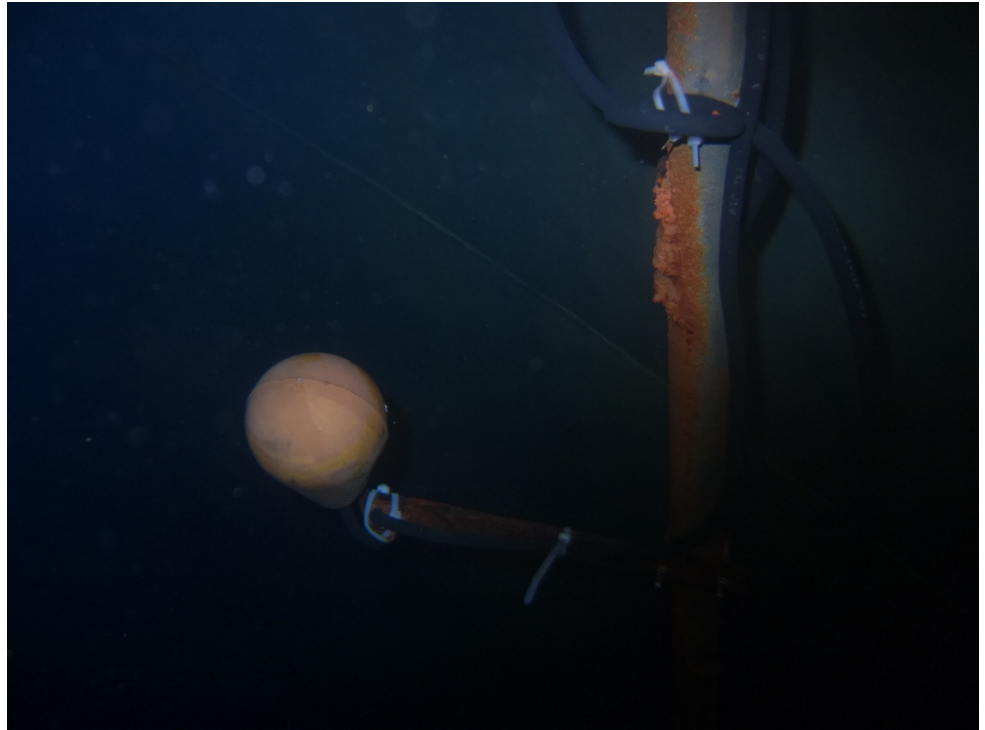
Image #31

Telemetry appears to be in good condition and properly suspended.

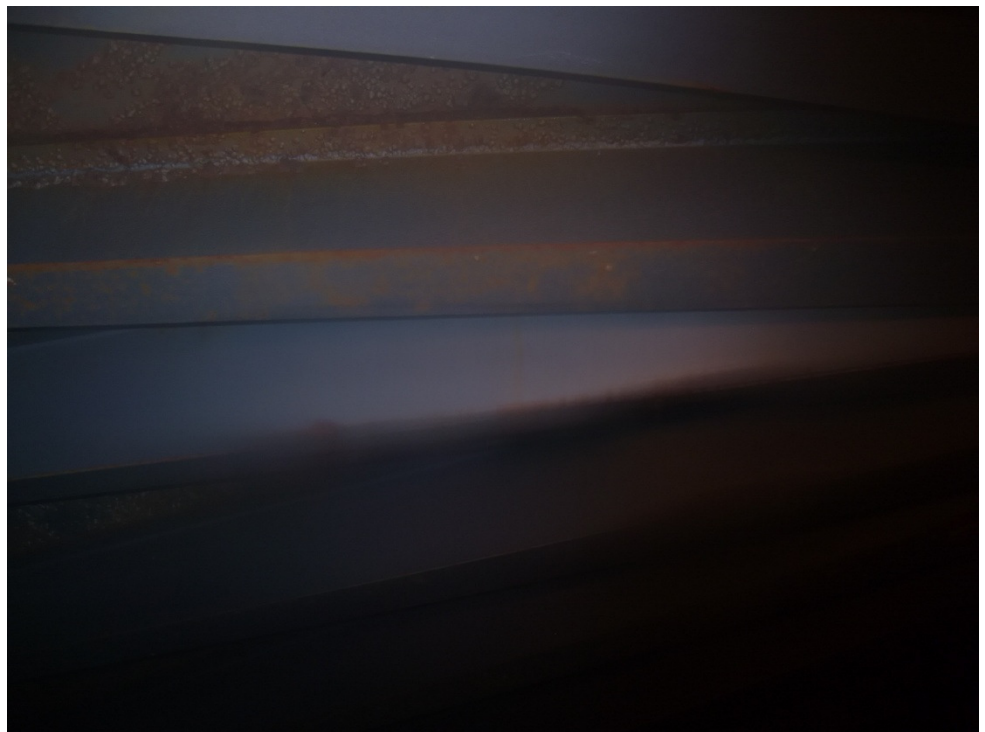
Image #32

Condition:
Rust Grade¹ 2.

Ceiling appears to be in fair condition with a heavy amount of corrosion.

Recommendation	Estimated Time - Hrs.
Remove the existing interior coating and apply a new NSF approved epoxy type coating. The existing interior coating was in such disrepair that it would not be cost effective to attempt to patch all of the problem areas.	Please contact our sales office for an estimate.
Perform a regular cleaning, inspection and repair cycle every 2-3 years in order to ensure superior water quality and proper maintenance of coating condition and appurtenances is performed.	Please contact our sales office for an estimate.
Total Estimated Hours

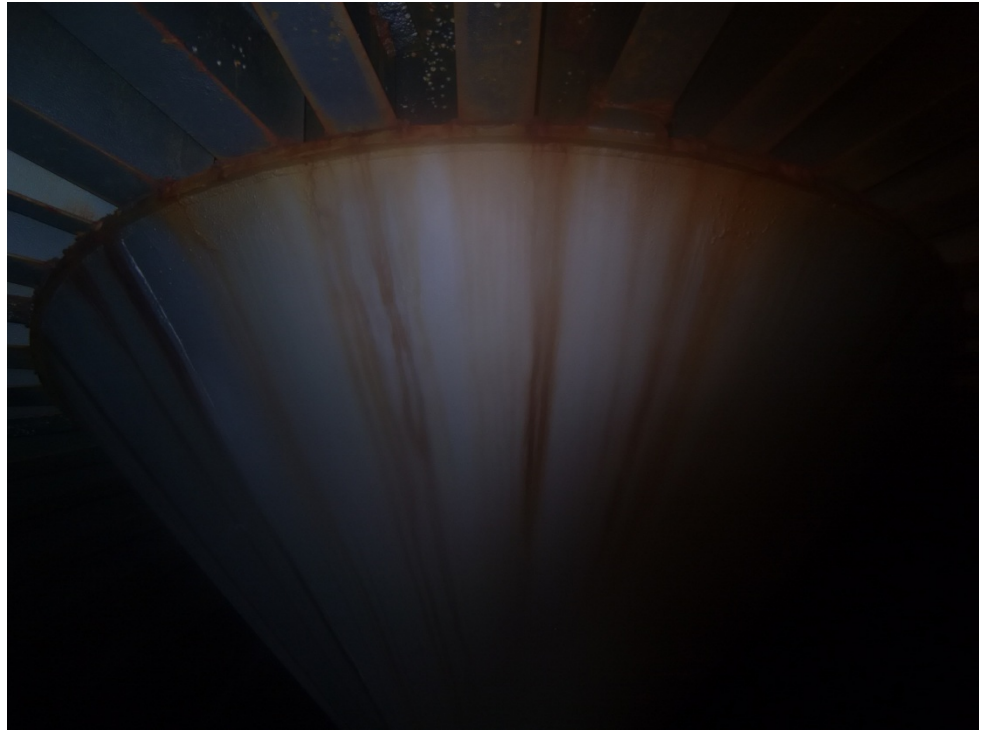
Image #33

Condition:
Rust Grade¹ 5.

Description:
Column appears to be
in fair condition with a
moderate amount of
corrosion.

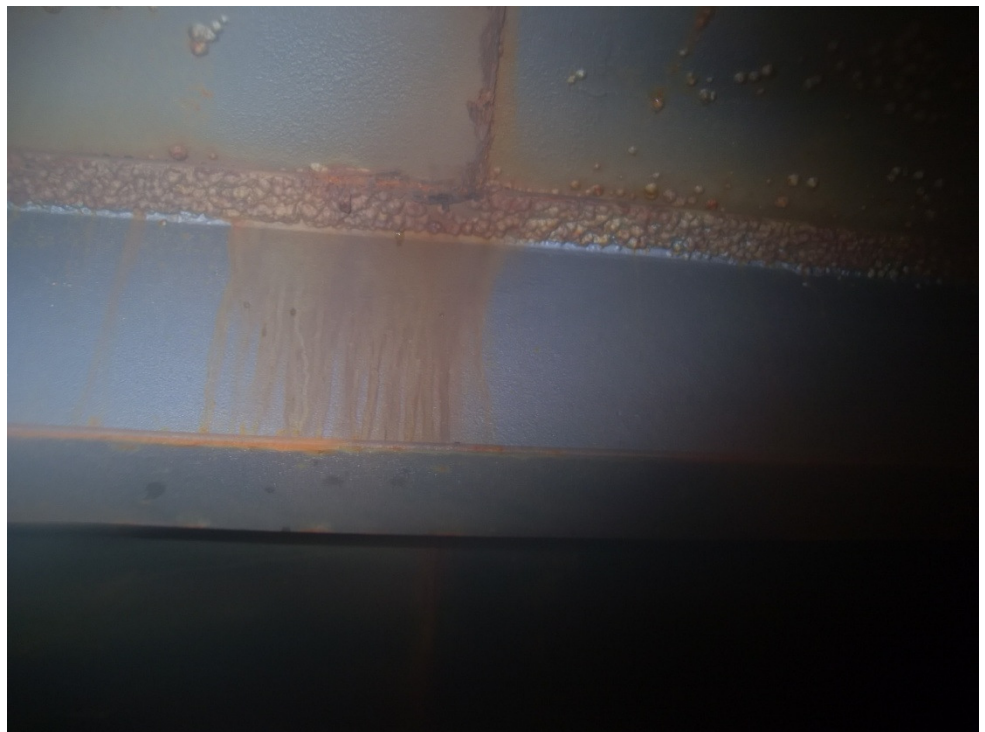
Image #34

Condition:
Rust Grade¹ 2.

Description:
Ceiling appears to be
in fair condition with a
heavy amount of
corrosion.

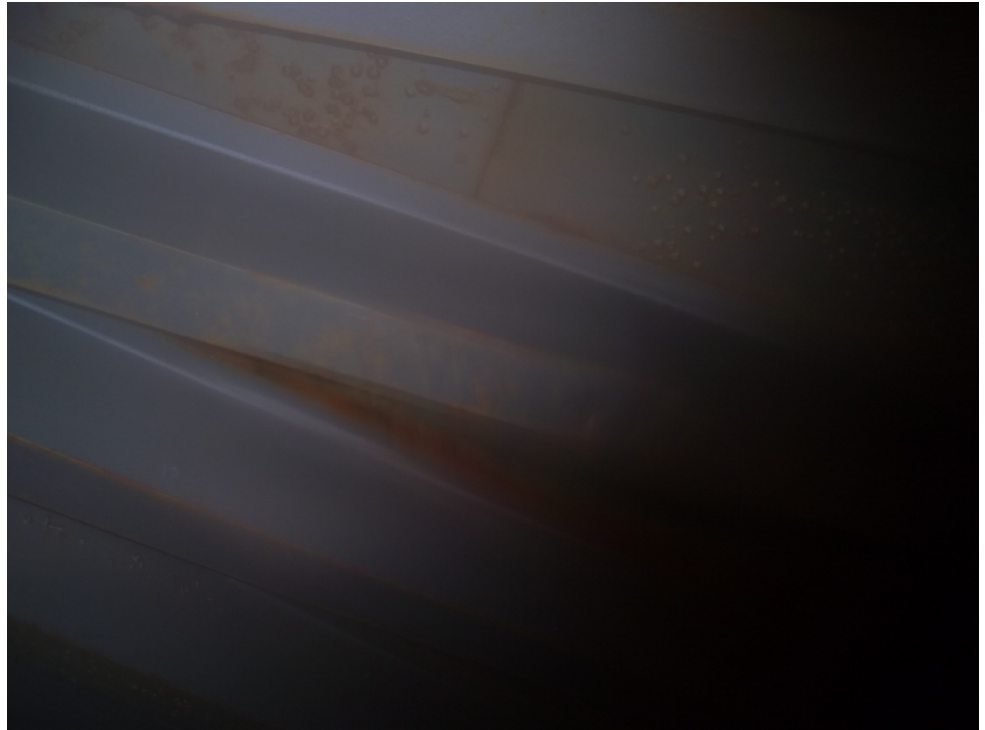
Image #35

Condition:
Rust Grade¹ 2.

Description:
Ceiling appears to be in poor condition with a heavy amount of corrosion.

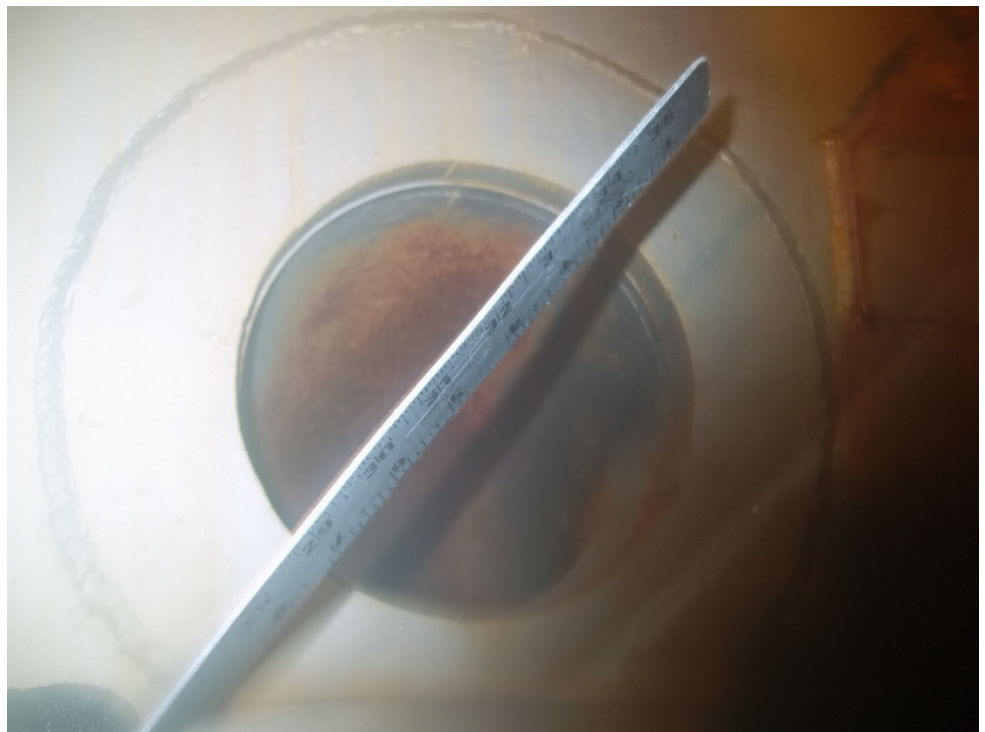
Image #36

Condition:
Rust Grade¹ 2.

Description:
8" Overflow appears to be in good condition with a moderate amount of corrosion.
